PERFORMANCE TEST REPORT

QUICK-BRICK, LLC

PRODUCT: Brick Samples

Report No: 65185.01-106-31
Report Date: 06/23/06
Expiration Date: 06/19/10

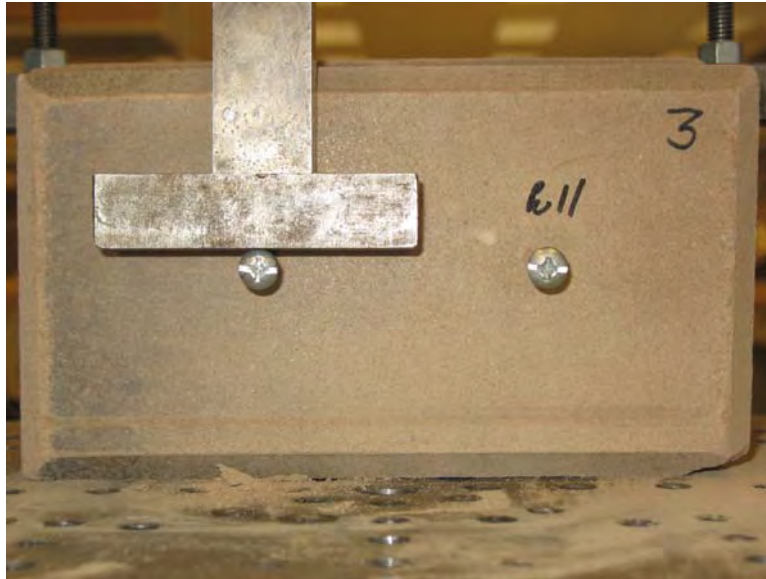
Photo No. 1
Shear Test Setup

Test Method: The test specimens were evaluated on a SATEC universal testing machine. The samples were comprised of brick material into which two #12 x 3" long sheet metal type fasteners had been installed by the manufacturer to a depth of 1.5". The first fastener in each sample was tested for shear strength while the brick sample was secured individually to the rigid steel frame of the testing machine. A force was applied to the fastener along the face of the brick in a downward direction at a rate of 0.25" per minute until failure. The remaining fastener in each sample was then tested for pull-out strength. The samples were secured individually to the base of the testing machine and a tensile force was applied at a rate of 0.25" per minute until failure.

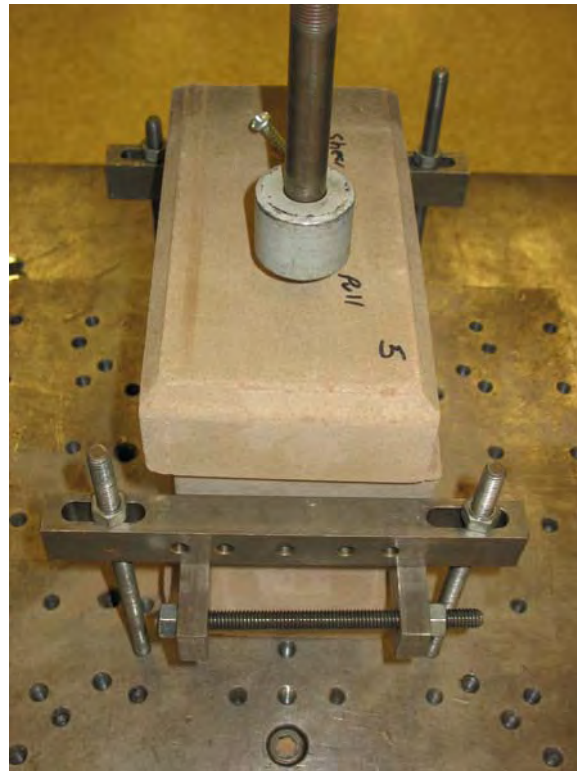
Photo No. 2
Pull-Out Test Setup

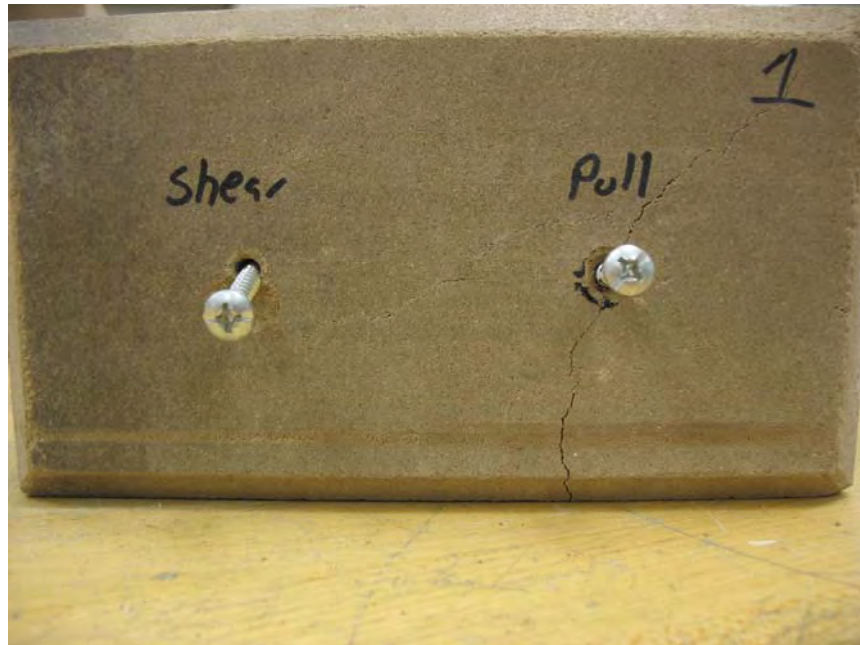
Photo No. 3
Brick 1 Result

Sample	Peak Shear Load	Peak Shear Strength ¹	Peak Pull-out Load
1	424 pounds	21,100 psi	681 pounds
2	524 pounds	26,100 psi	603 pounds
3	414 pounds	20,600 psi	631 pounds
4	460 pounds	22,900 psi	70 pounds ²
5	416 pounds	20,700 psi	714 pounds
Average	448 pounds	22,280 psi	657 pounds

¹ - The mode of failure for these tests was brick spalling and cracking. The failure loads listed do not represent metal shear of the fastener.

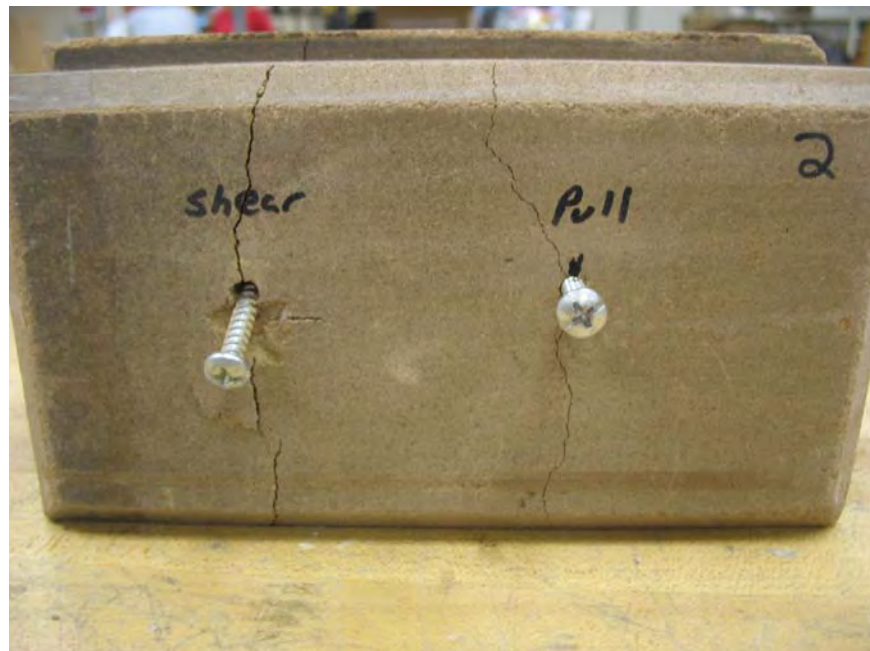
Photo No. 4
Brick 2 Result

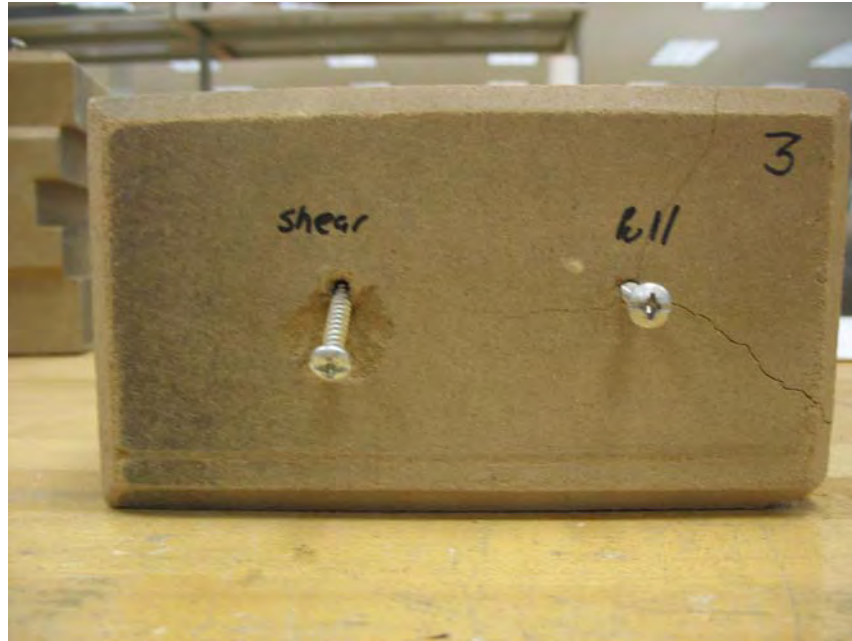
Photo No. 5
Brick 3 Result

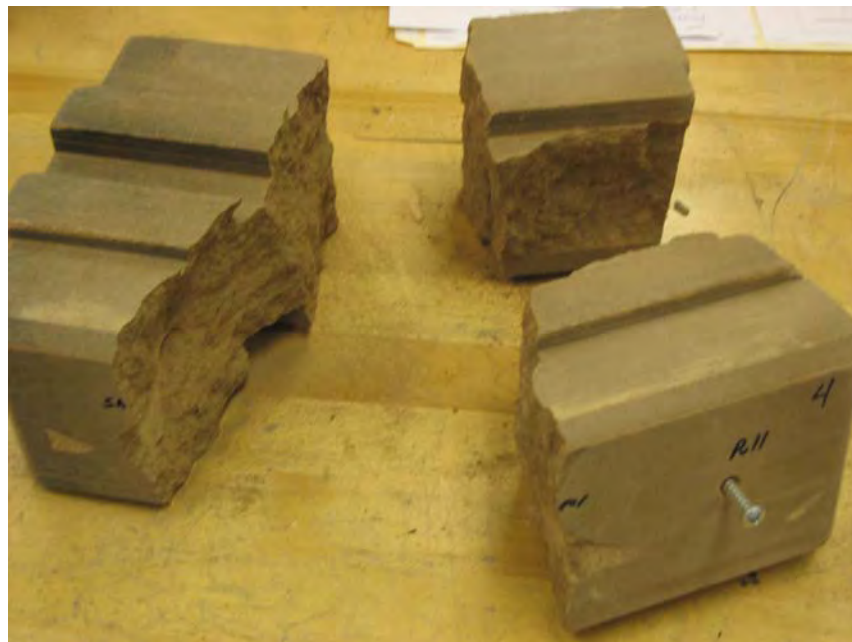
Photo No. 6
Brick 4 Result

² - The pull-out value for Sample 4 is suspect due to the result of damage of the brick caused by the adjacent shear test. This resulting value has been removed from all calculations.

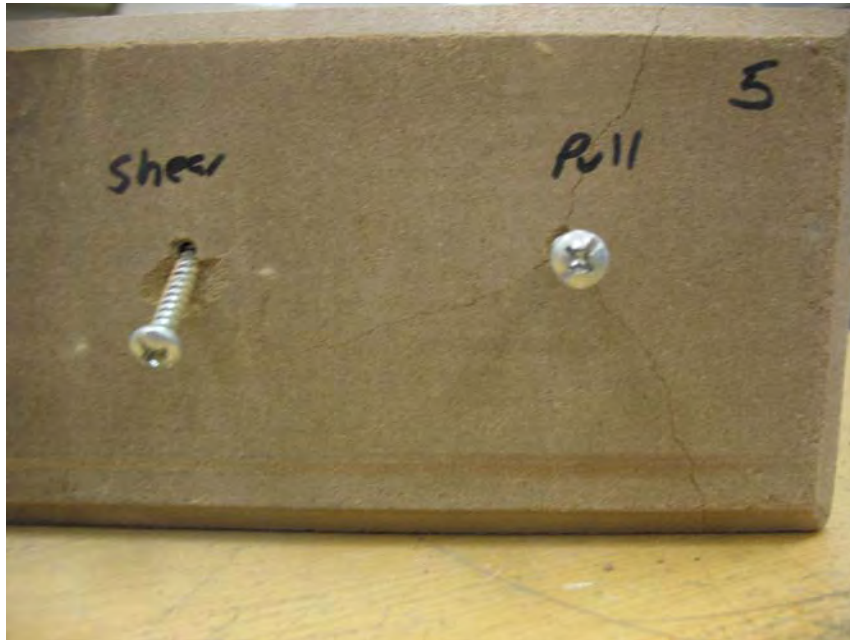
Photo No. 7
Brick 5 Result
