CERTIFIED TESTING LABORATORIES

Report Number: CTLA 1479W
Report Date: April 17, 2006

STRUCTURAL PERFORMANCE TEST REPORT

Test Specifications: ASTM E72-98 (With Deviations Structural loads only) "Standard Test Methods of Conducting Strength Tests of Panels for Building Construction"

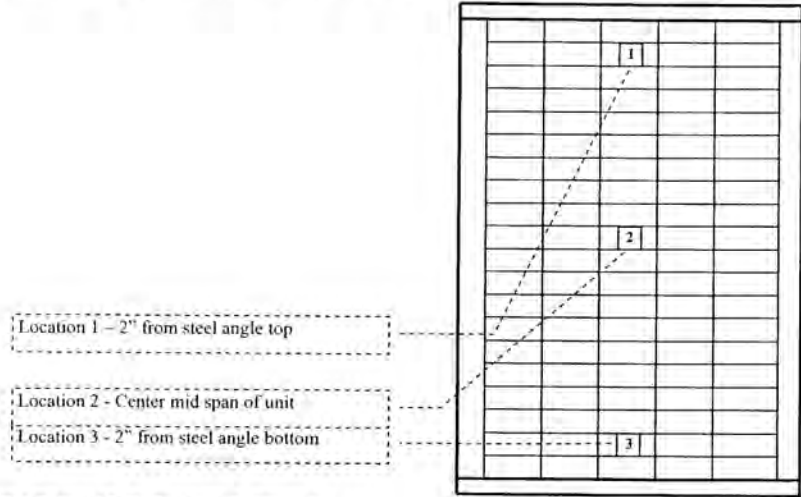
Deflection Gauges Set At Boxes 1, 2, & 3 – Measurements

were taken with three (3) Dynavision Laser indicators location #1 SN S1002136, location #2-SN S1002143 and location #3-SN S1002144

Specimen 1 +80.0 psf - 80.0 psf

All loads run in the negative or uplift

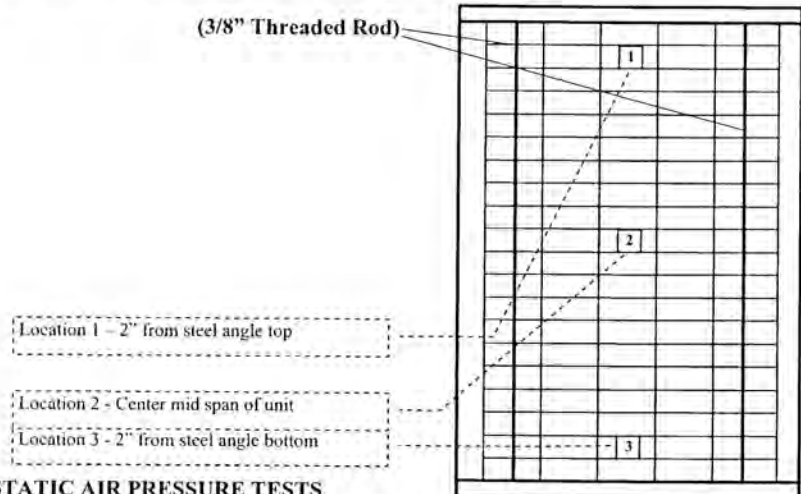
Deflection Gauges Set At Boxes 1, 2, & 3 – Measurements

were taken with three (3) Dynavision Laser indicators location #1
 SN S1002136, location #2-SN S1002143 and location #3-SN S1002144

Specimen 2 +150.0 psf - 150.0 psf

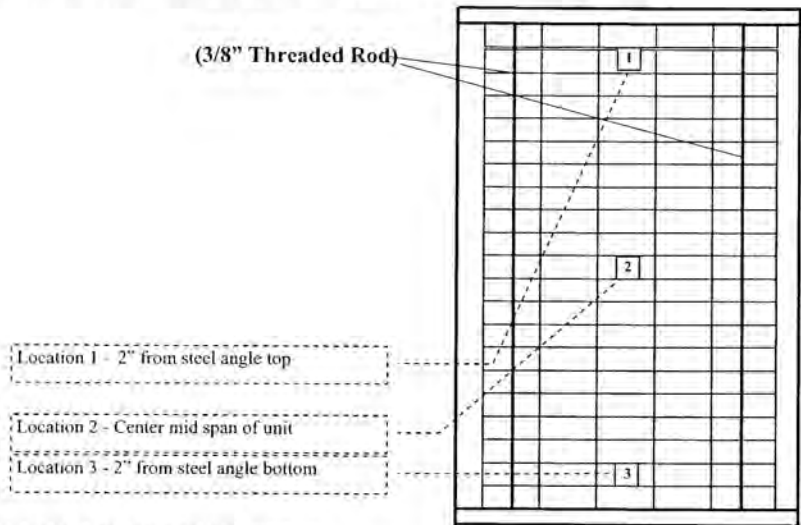
Deflection Gauges Set At Boxes 1, 2, & 3 – Measurements

were taken with three (3) Dynavision Laser indicators location #1 SN S1002136, location #2-SN S1002143 and location #3-SN S1002144

Specimen 3 +80.0 psf - 80.0 psf
